History... This is a 19 year old male. The patient presented with symptoms of pain full left shoulder with limited range of motion post football injury.

Findings... The patient was found to have a prominent SLAP (*this stands for Superior Labral tear from Anterior to Posterior*) lesion which extends down to include the length of the posterior glenoid labrum and the entire inferior glenoid labrum as well.

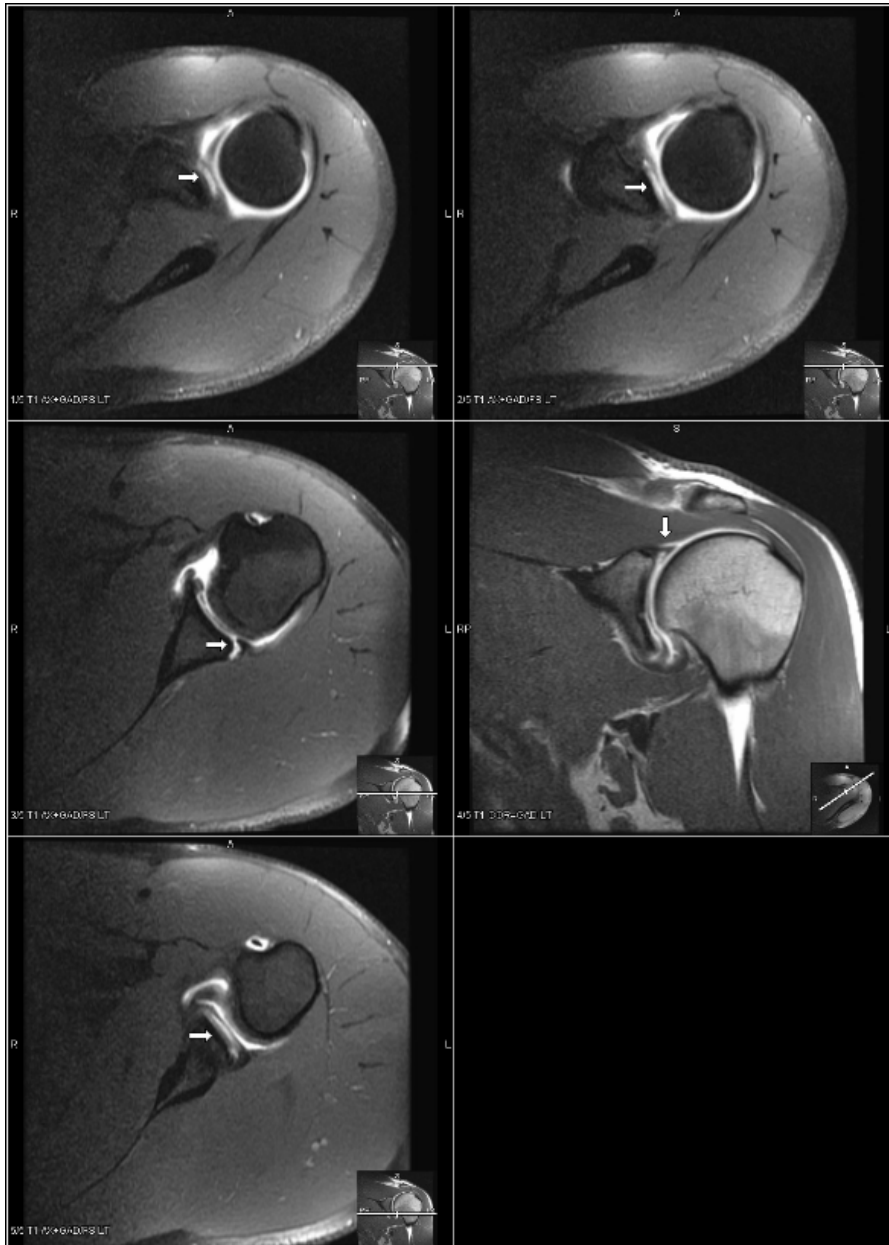
*These images were acquired from a 1.5 Tesla MRI with *Excite*TM Technology.

These images are from an MRI shoulder arthrogram study. An MRI shoulder arthrogram is an effective method for the evaluation of shoulder injuries.
